Manhole Inspection Summary

Manhole # S11GG1001MH

Insp Date: **5/22/07 3:11 PM**

Location Address: **4353 REISTERSTOWN RD**

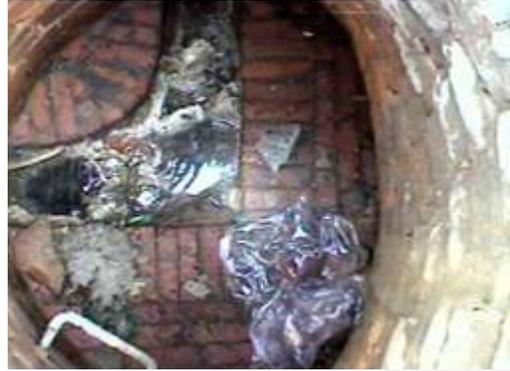
Top View

Condition: Sound Cracked Root Intrusion Deteriorated Leaks Debris

DEBRIS ON BENCH AND IN CHANNEL

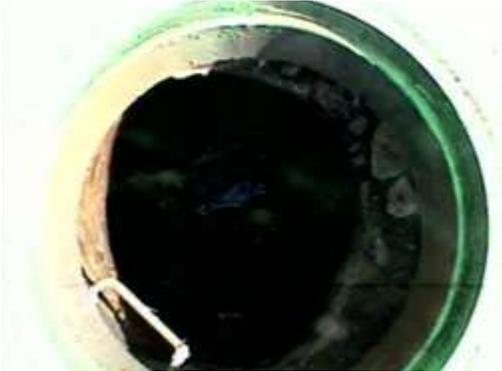
Top View

Frame Offset: **3.5** (in.) Condition: Sound Cracked Leaks

OFFSET

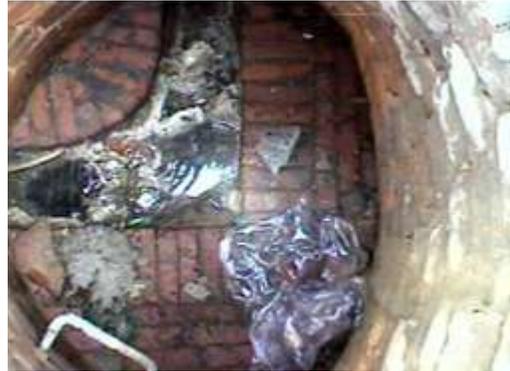
Defect 2

Surcharge **Evidence Of Surcharge** Depth: **2.5** (ft.) Active Surcharge Present

EVIDENCE OF SURCHARGE

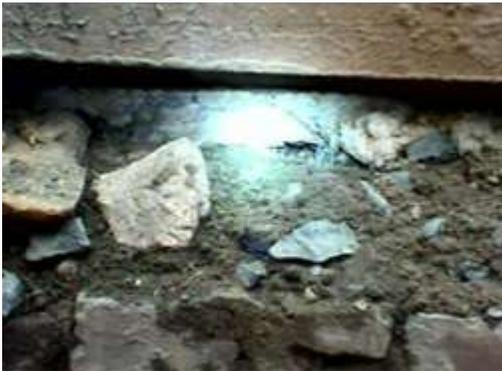
Defect 1

Condition: Sound **Cracked** Root Intrusion **Loose Brick** **Deteriorated**

LOOSE BRICKS DETERIORATED
CHIMNEY

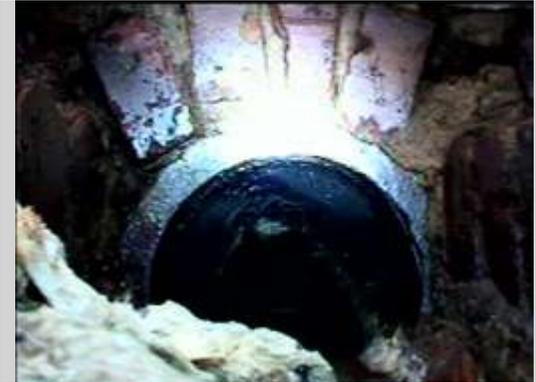
12 O'Clock Outflow

Pipe Height: (in.) Direct
Pipe Material: **Clay** Pipe Lined
Invert Depth: **6.51** (ft.) Flow Characteristics: **Slow**
Deposits: None Mud ~~Sludge~~ Debris Grease
Silt Depth: (in.) Deposits Extent:
Infiltration: **None** Pipe Seal Cond: **Sound**

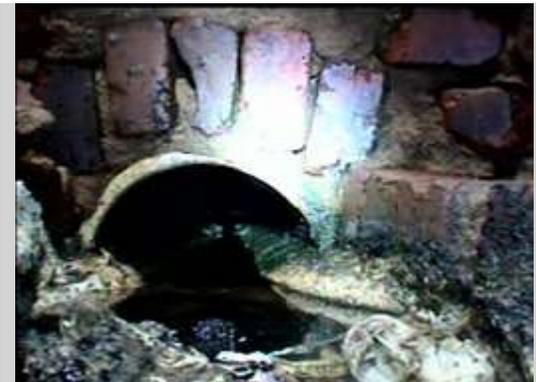
9 O'Clock Inflow

Pipe Height: (in.) Direct
Pipe Material: **Clay** Pipe Lined
Invert Depth: **6.42** (ft.) Flow Characteristics: **Slow**
Deposits: None Mud ~~Sludge~~ Debris Grease
Silt Depth: **4** (in.) Deposits Extent: **Heavy**
Infiltration: **None** Pipe Seal Cond: **Sound**
